**Flood Control Project Maintenance
Levee Inspections**

Maintenance Issue Types Only, Levee Inspection Report By Mile - Fall 2018

Reclamation District No. 2089 Stark

Waterway	Bank	Unit Miles	Inspection Start/End	Inspector
Unit No. 01 Old River	Right	1.51	10/31/2018 10/31/2018	Richard Willoughby

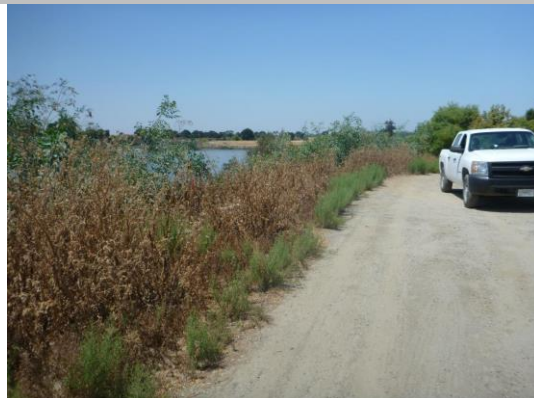
Photo 3 of 3 : LEVAL_FA_2018_507_4340.jpg

LM Start	0.60	Rating **	A/W	Issue No.	56 (cont)	
LM End	0.61	Issue Type +	Ma	Location *		
Category	Supplemental			GPS Latitude/Longitude		
				Start		End
Item	2017 Storm Damage			37.812000 °		37.812100 °
				-121.415700 °		-121.415900 °
DWR ID	DWR_RD2089_02_s_2018_56					
Comment Code						
Inspector Comment						
Levee Evaluation Comments						
Description:Slope protection repairs are needed along the waterside slope due to erosion and riprap displacement from high water. Based upon levee inspections, it was determined the waterside levee slope is eroding, deteriorating, and degrading. The eroded levee sections need to be restored back to design standards to prevent further deterioration and damage.						
Site ID No:507						
Site Designation:LMA-413						
Repair Type: Erosion						
Rating:Serious						
Field Date:8/16/2017						
Notes: Vertical cut on outside bend of river
